FURTHER STUDIES OF ATCRBS BASED ON
ARTS-III DERIVED DATA

A. G. Cameron

Massachusetts Institute of Technology

1. Report No. FAA-RD-74-145	2. Government Accession No.	3. Recipient's Catalog No.	
4. Title and Subtitle Further Studies of ATCRBS Based on ARTS-III Derived Data		5. Report Date 13 December 1974

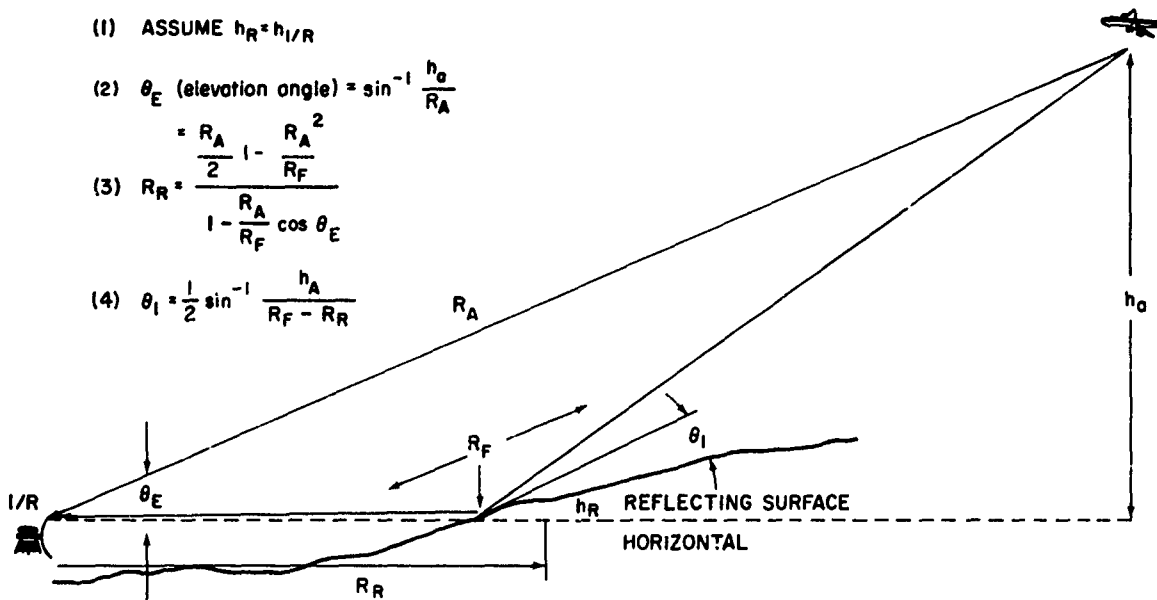
$$h_a = h_{\text{reported}} + h_{\text{earth curvature}} - h_I/R$$

$h_{\text{correction}}$ CONVERTS FOR BAROMETRIC VARIATIONS AND NEED BE APPLIED ONLY TO AIRCRAFT IN THE PCA. ARTS III REFERENCES THEM TO 29.92" vs ACTUAL BAROMETRIC.

(4) $\theta_I = \frac{1}{2} \sin^{-1} \frac{h_A}{R_F - R_R}$

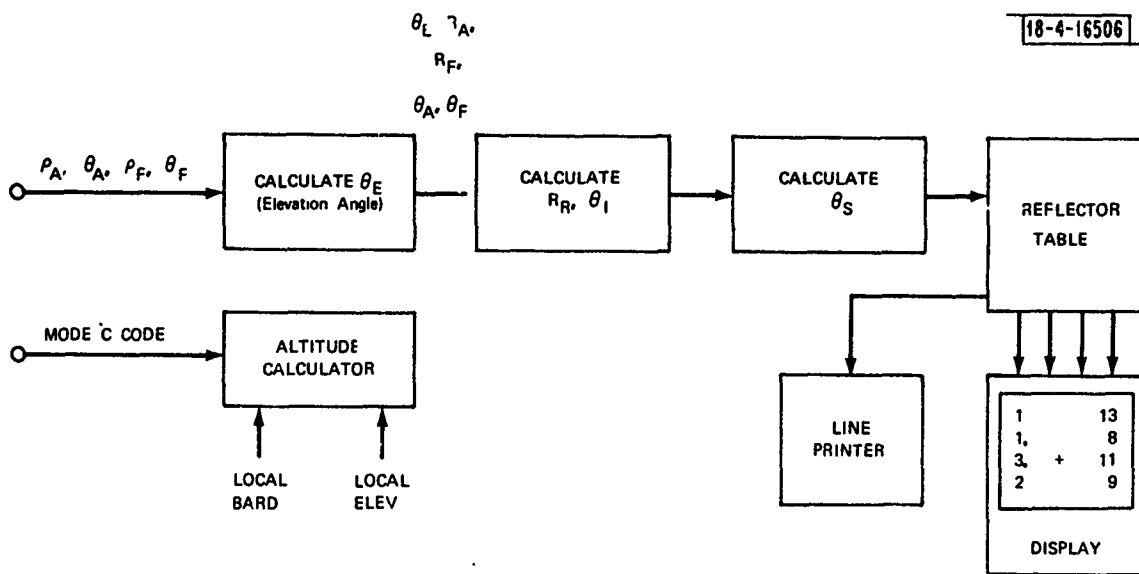
Fig. 23. Mainbeam reflection processing.

1. False target reports are examined to determine if two or more overlap in azimuth.

2. If so, then the report at greater range is treated as a conventional false target, and processed as such. The report at lesser range is treated as a sidelobe report (resulting from the geometry of Fig. 24), and should be ignored.
3. If only one false target report is noted at a particular azimuth, then it is not clear whether it is caused by one or the other mechanism. Both mechanisms are assumed, and reflector locations corresponding to both are determined. If one or the other correlates well with a reflector noted on other data, it can be combined with it, and the other can be dropped.

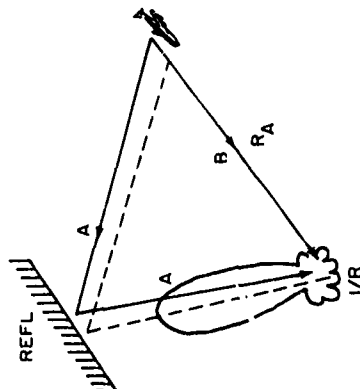
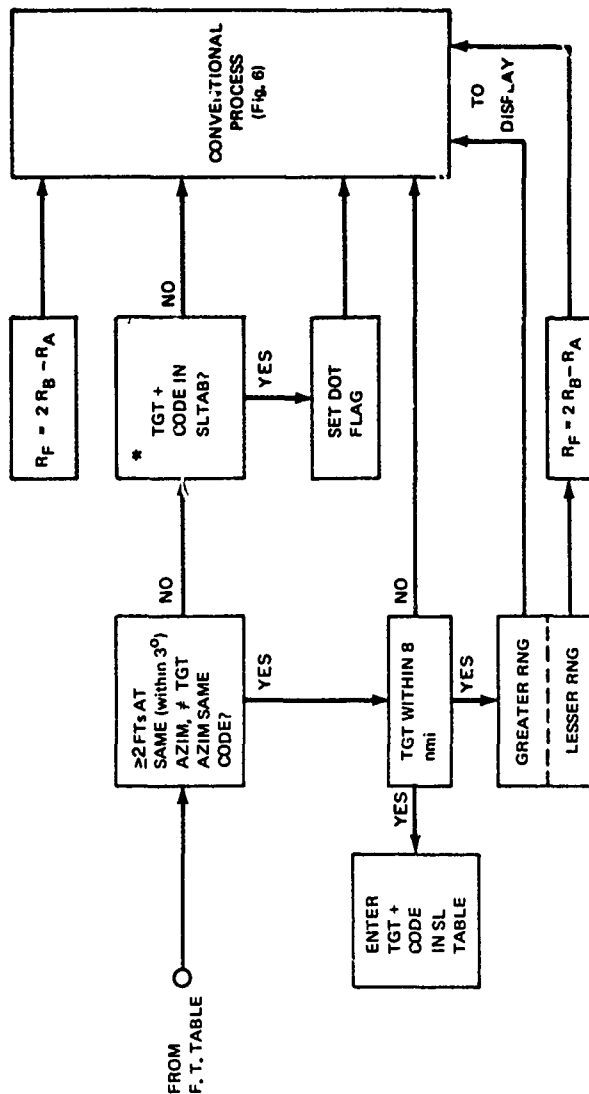
FALSE TARGETS DUE TO RETURN PATH A CAN BE PROCESSED AS CONVENTIONAL

FALSE TARGETS DUE TO RETURN PATH B MUST FIRST HAVE APPARENT RANGE CORRECTED: $R_F = 2 R_B - R_A$
WHERE R_B = MEASURED RANGE R_F = RANGE OF F. T. TO BE INPUT TO CONV. PROCESS

Fig. 24. Sidelobe reply processing.

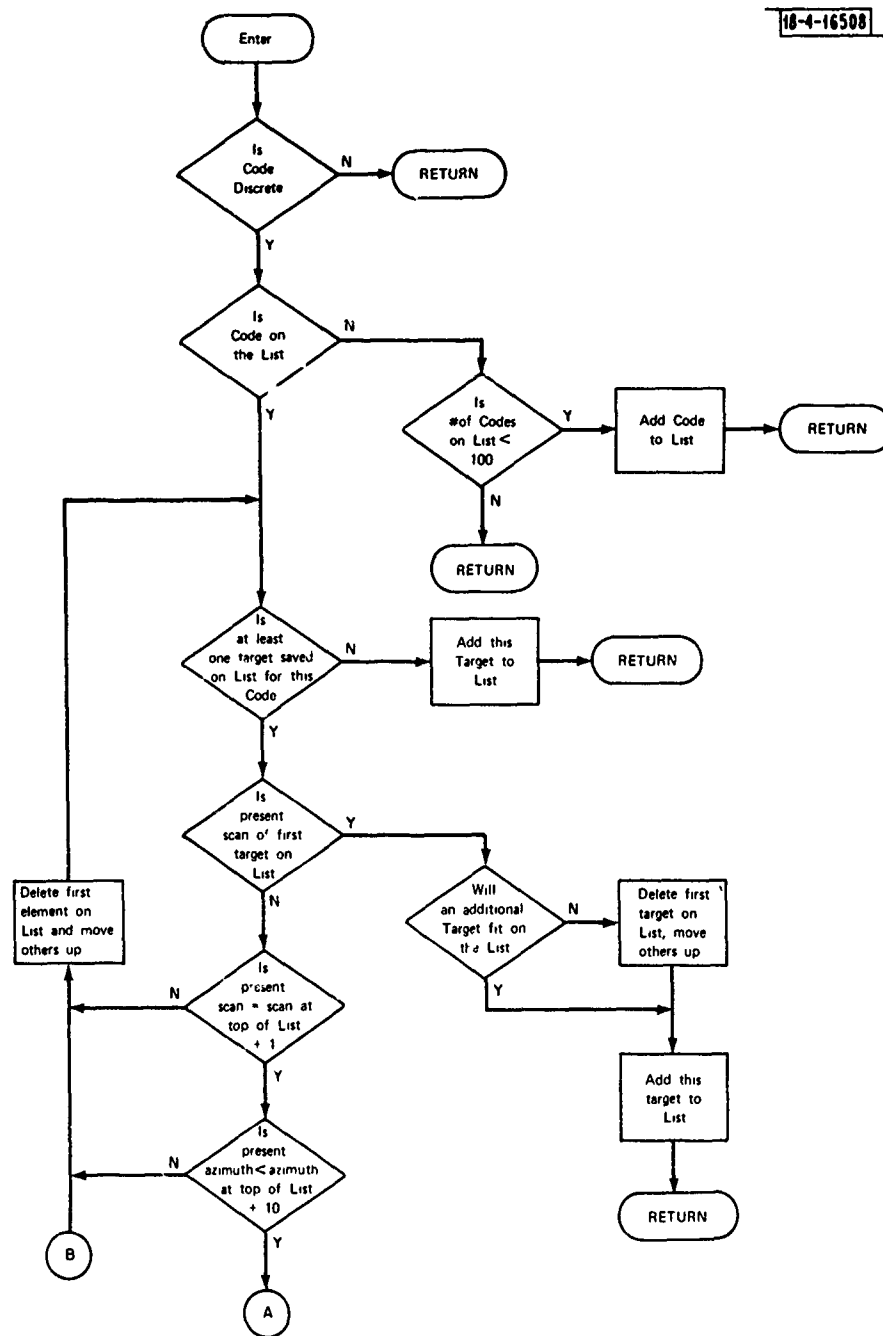
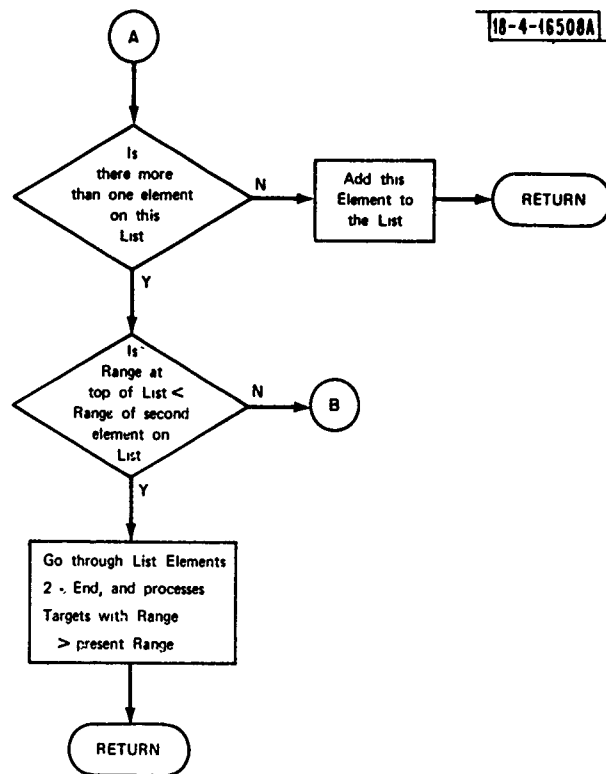
Fig. 25. Program flow chart*.

Fig. 25. (continued).

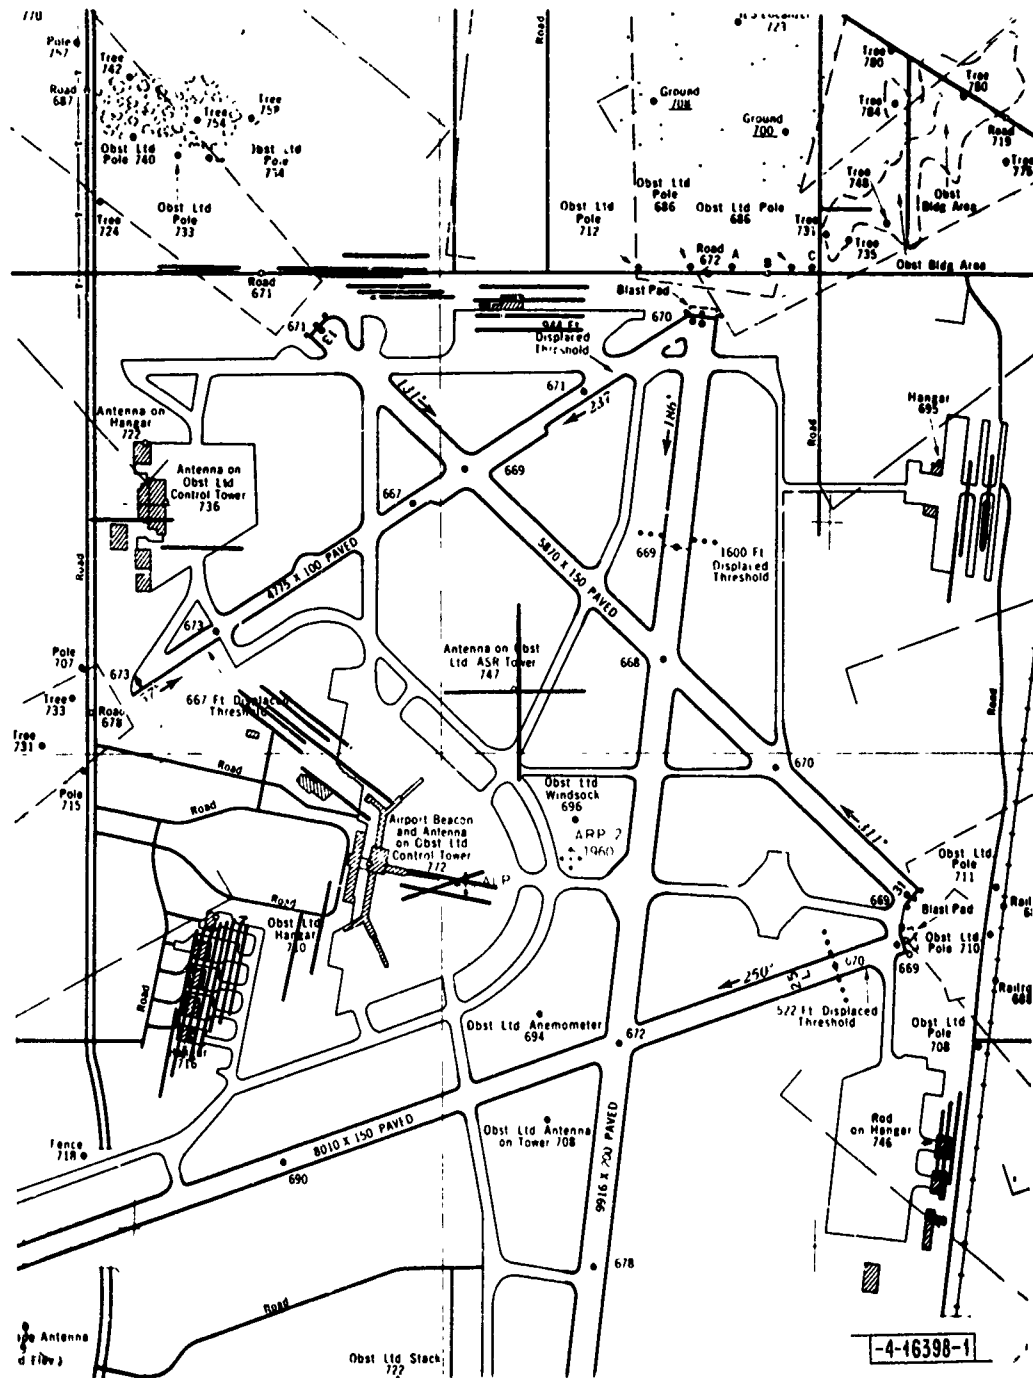
Fig. 27. Processor outputs (straight lines) superimposed on obstruction chart.

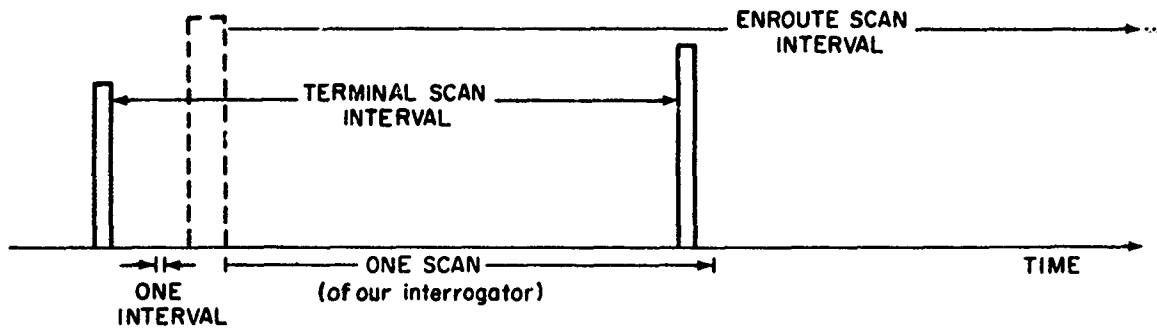
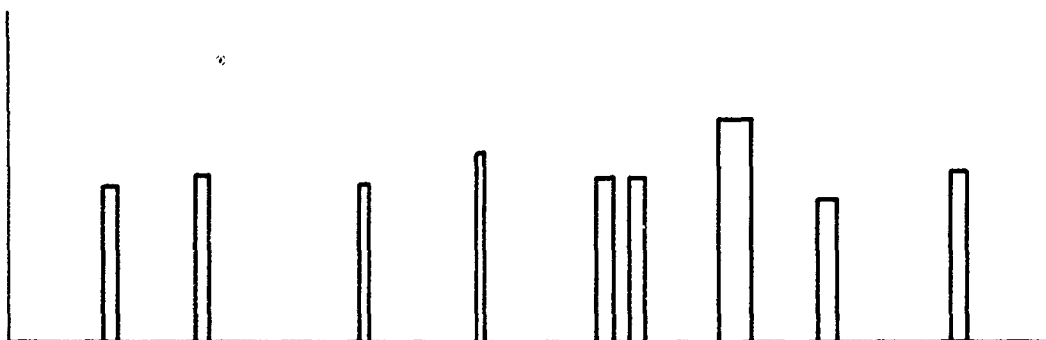
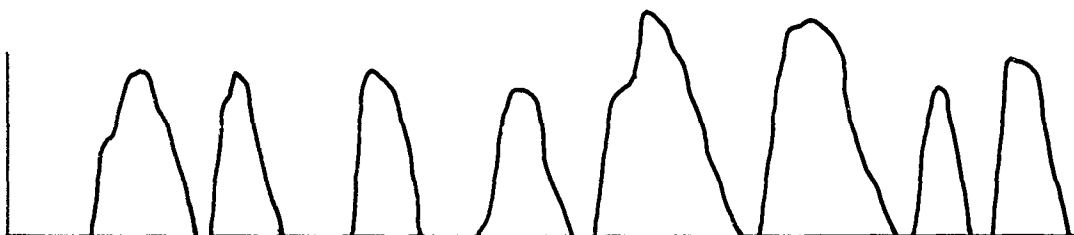
(a) Fruit pattern due to a single interrogator
(—— terminal interrogator; ---- enroute interrogator)

(b) Composite pattern of fruit from one aircraft
due to several interrogators

(c) Total fruit count predicted from aircraft distribution,
assuming same interrogator environment as in (b)

Fig. 28. Idealized fruit patterns.

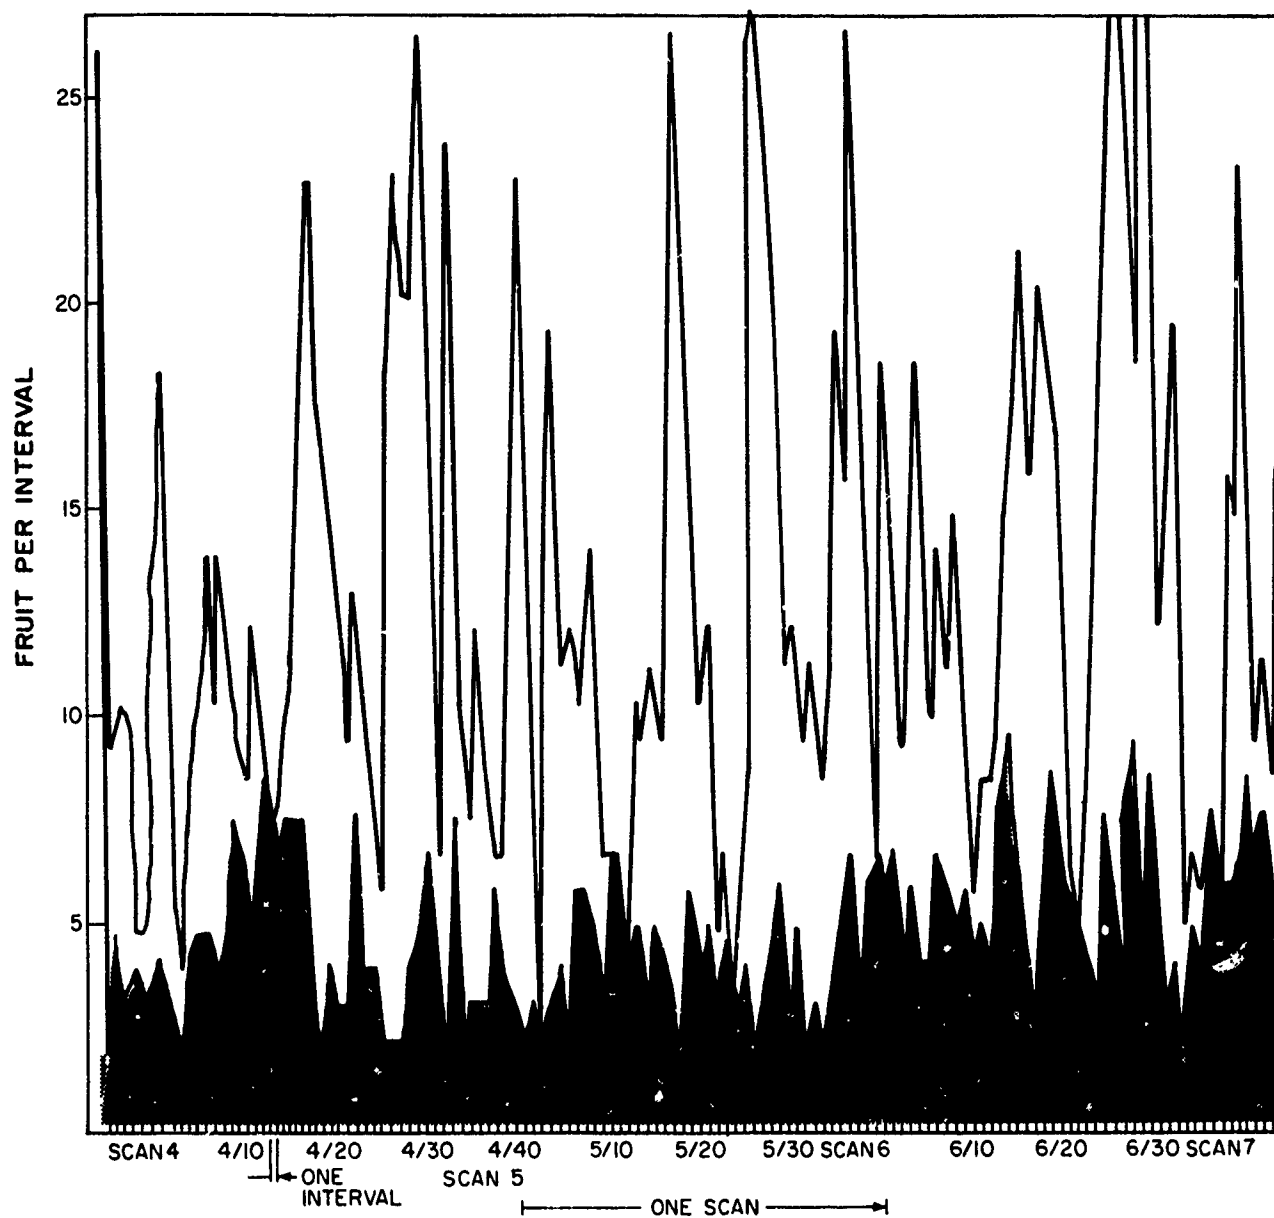
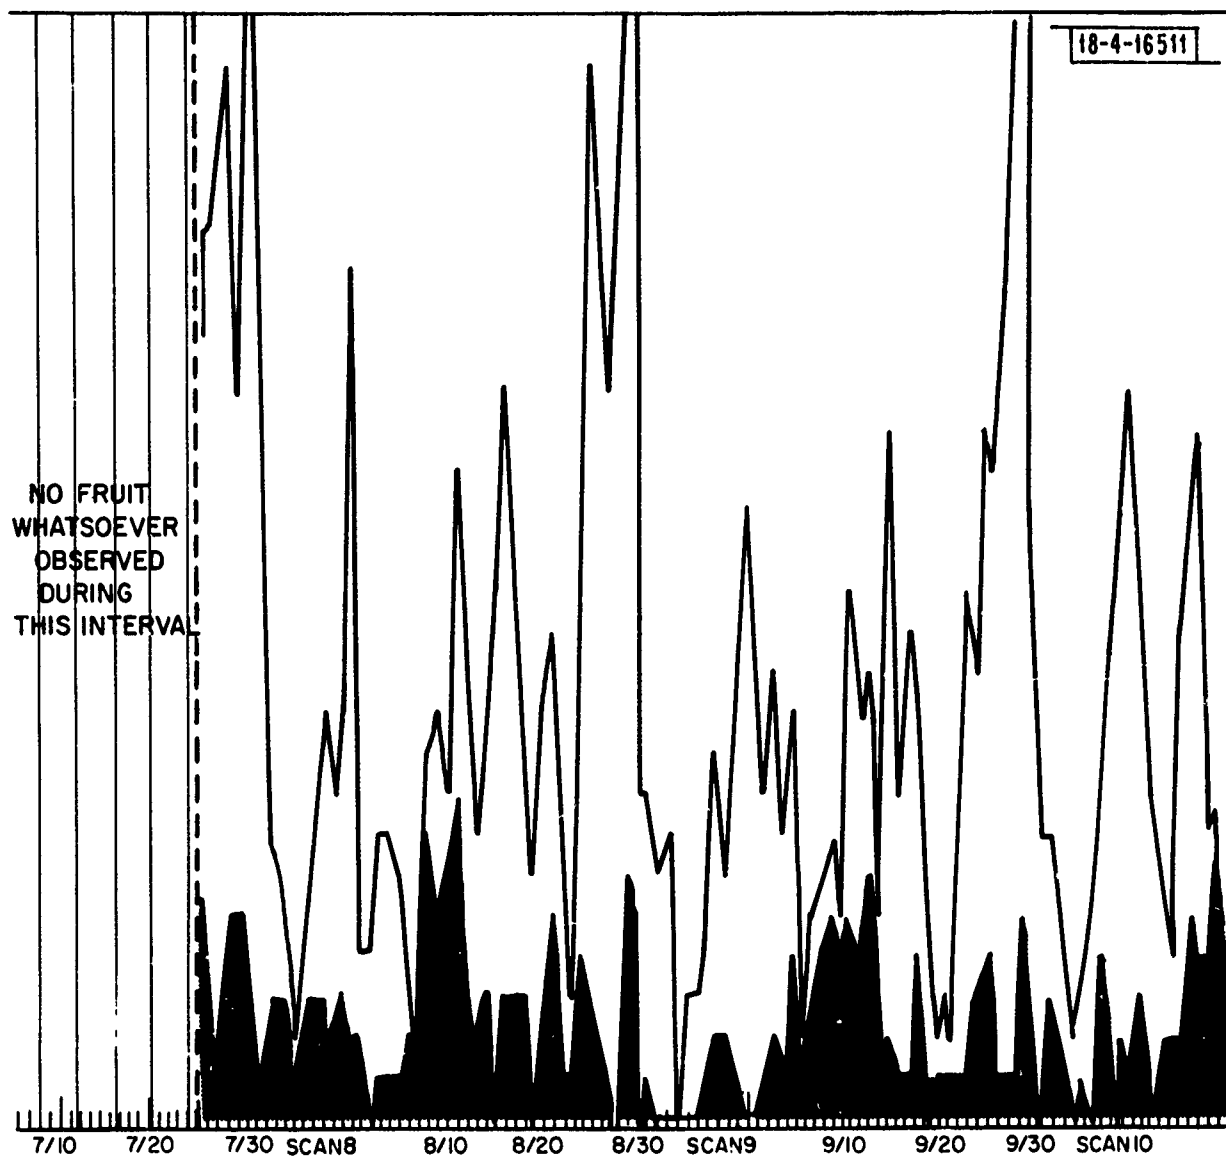
Fig. 29. Fruit arrival rates versus time.

Fig. 29. (continued).

Note that a substantial portion of scan 7 is devoid of any fruit whatsoever. This was originally assumed to be a result of the (assumed) low number of interrogators in the vicinity; no fruit was sensed simply because no other interrogators happened to be interrogating the aircraft within 10 nmi during

that period. Cursory examination of the data in Fig. 29 reveals that this is extremely unlikely; the dead time is probably due to inadvertent switching of the defruiter back into the system for a brief period. Note that it happened only twelve seconds after the defruiter was initially switched out (the technician at the radar site most likely still had his hands on it then).

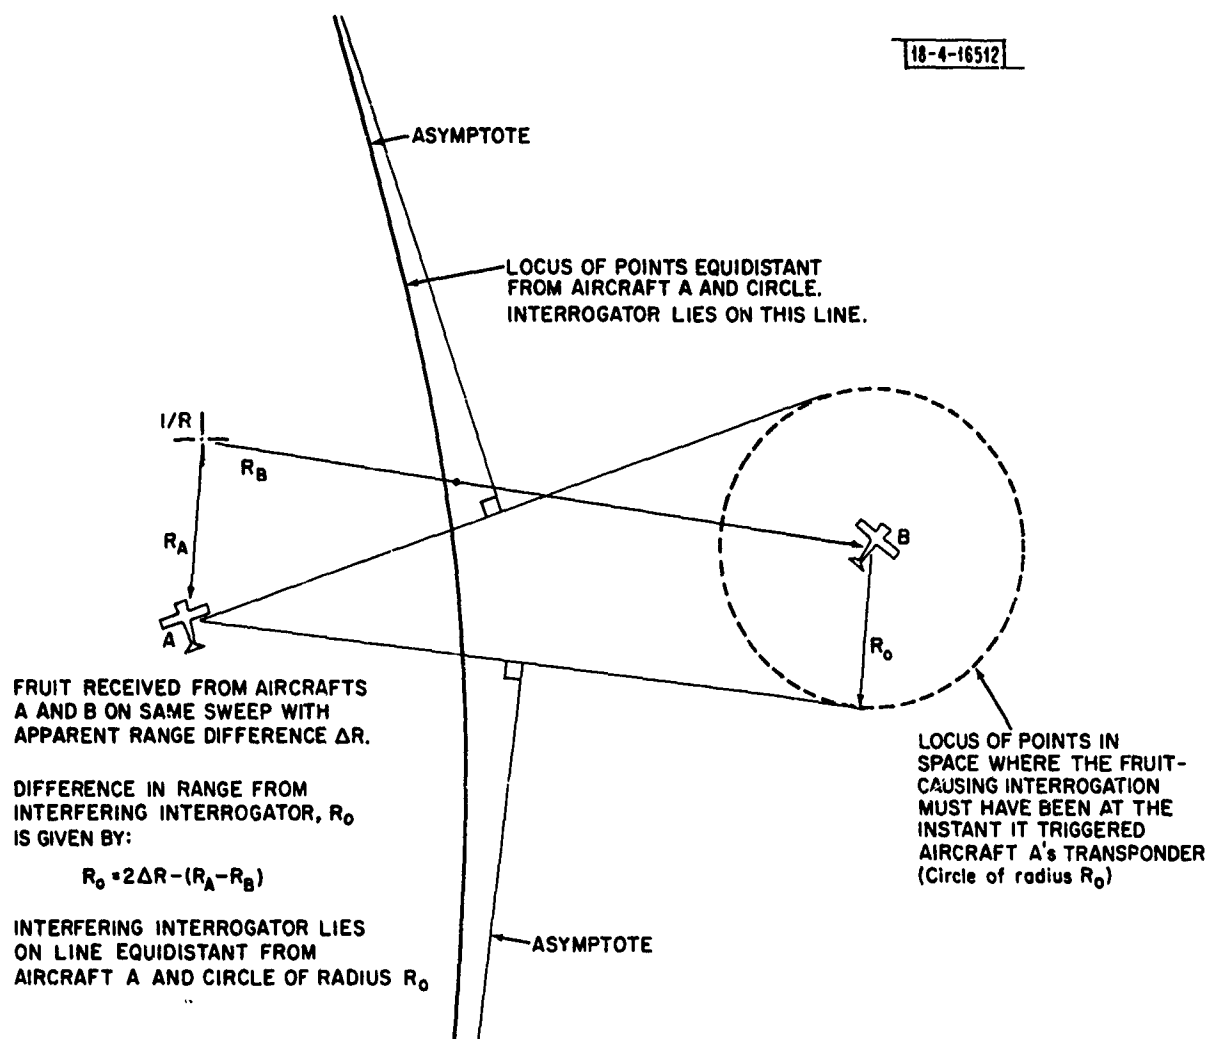
Fig. 30. Direction-finding from multiple fruit on a sweep.

Three attempts at locating interfering interrogators were made using Boston data. Each indicated a particular location, roughly consistent with known interrogator locations. Each was the result of a different interrogator; this is not surprising given the large number of interferers measured in the Boston data.

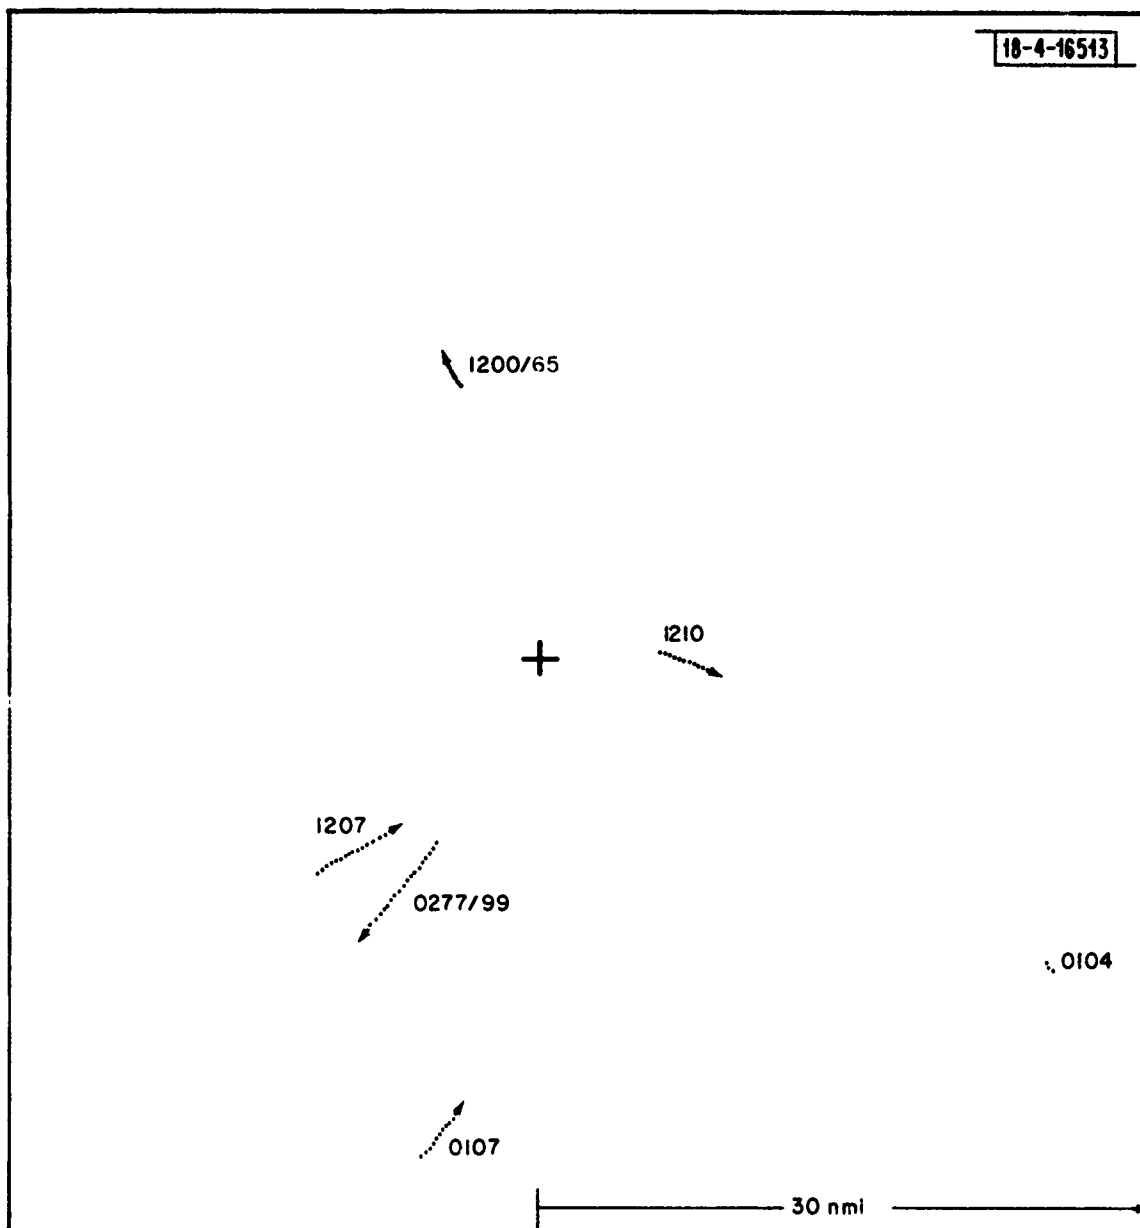
Fig. 31. Aircraft tracks - MSP scans 70-40.

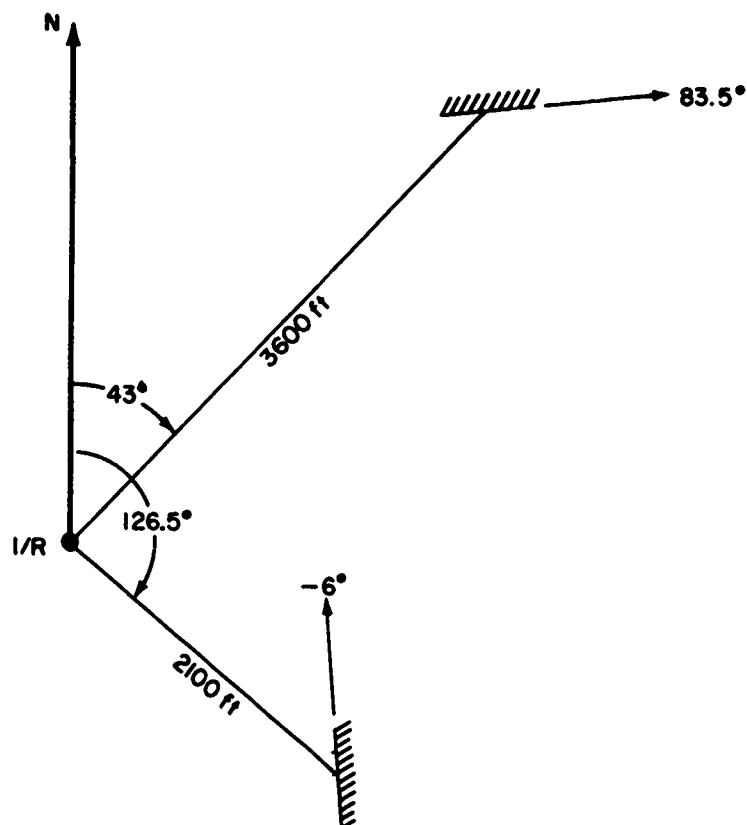
Fig. 32. Reflectors at MSP.

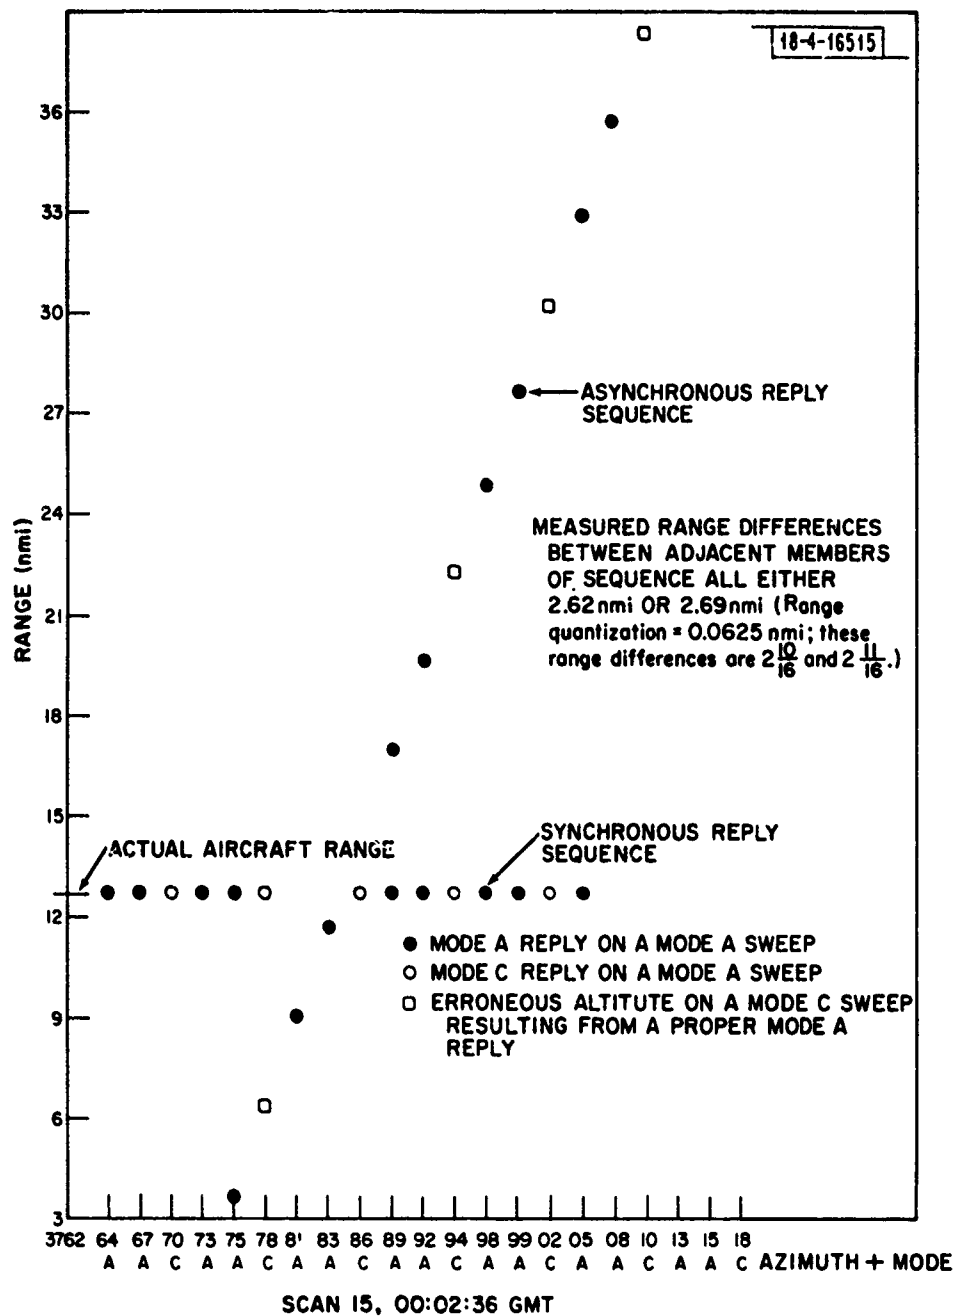
Each tick denotes a sweep. Numbers are the last two digits of the ACP.

Fig. 33. Fruit pattern - MSP.

Another point which is evident from Fig. 33 is worth mention. Note that on sweeps 81 and 83 the synchronous reply is suppressed, because the synchronous interrogation follows too closely after the interrogation of the ARSR. Similarly, on sweep 86 the fruit reply is suppressed because it follows

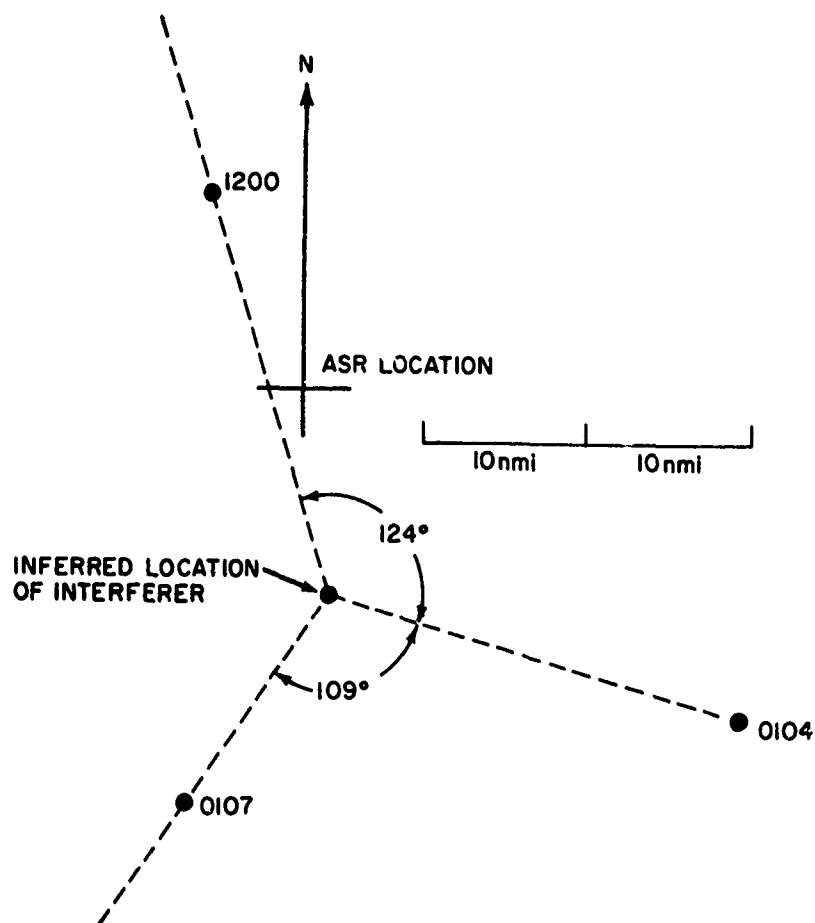
Fig. 34. Determination of interferer location.

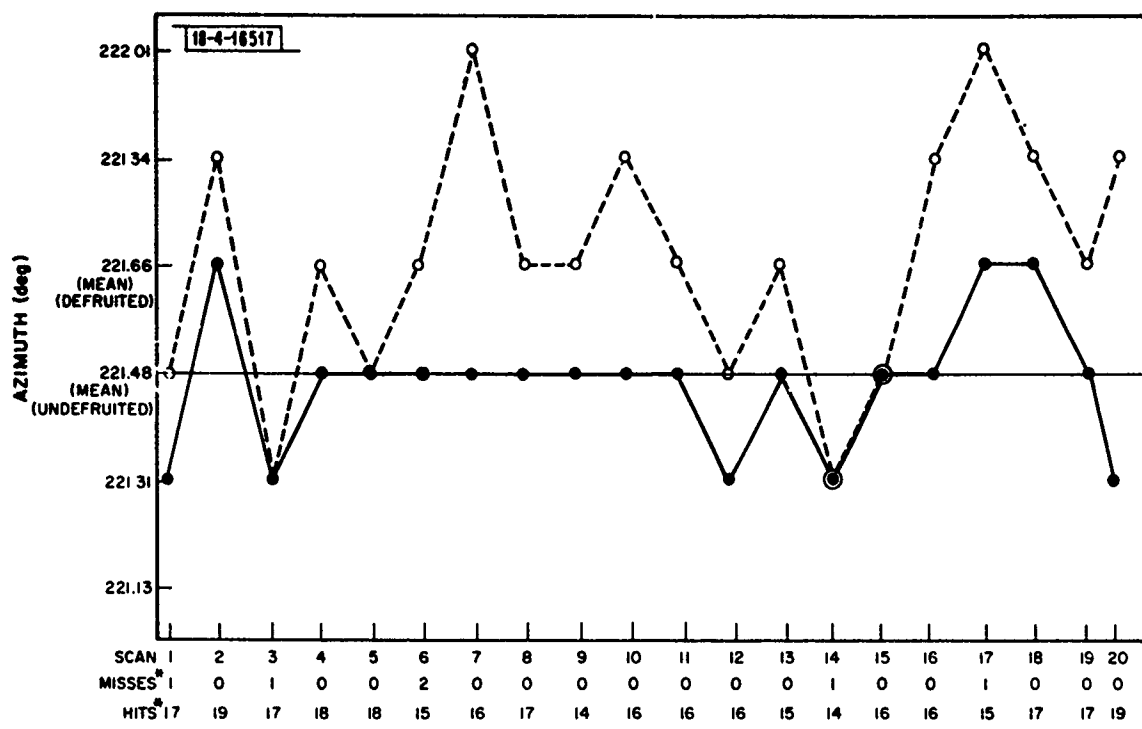
*IN UNDEFRUITED DATA

Fig. 35. Azimuthal accuracy.

A single target squawking both modes departing radially at relatively long range was tracked over twenty scans (from about 42 to 51 nmi). The target radial velocity held constant at 412.5 kt. Figure 35 plots the azimuth of the aircraft on each scan as determined by both systems. Making the somewhat questionable assumption that the aircraft actual azimuth remains constant at its average as seen in the undefruited data, we see that, for the data, the maximum azimuthal error in 20 scans is 0.175° (about 2 ACP's), and the rms error is 0.11° (about 1.25 ACP's). Corresponding values for the defruited data are 0.35° maximum (about 4 ACP's) and 0.192° rms (about 2.18 ACP's). These figures take into account the bias error introduced by leading reply suppression in the defruiter, and are worse for exactly the reasons one would expect: occasional missed initial mode C replies tended to make the leading edge "noisier," and holes in the reply sequence due to suppression were doubled in size by the defruiter. This latter phenomenon impacts on ARTS-III performance because of the center-of-gravity beamsplitting procedure employed. It should be noted that the reply probability of the aircraft in question was exceedingly high ($>98\%$ from Fig. 24) and a lower reply probability would tend to make both processes noisier, especially, in the defruited case.

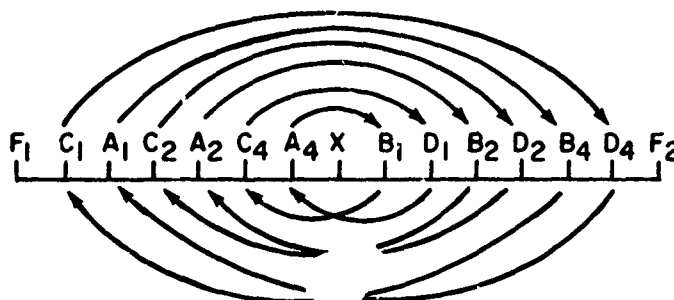
Fig. 36 Relationship between anomalous and legitimate reply pulses.

The pattern by which these pulses are related is shown in Fig. 36. The arrows point from the actual pulse which must be present in the original code to the incorrect pulse which it causes in the anomalous code; note that the relationship is non-reciprocal.

While the relationships among the pulses are certainly regular and consistent, it is apparent from the diagram that they cannot be explained by any simple mechanism which could be related to multipath phenomena such as a fixed delay, or a combination of delays. However, the manner in which a) D, A, B, and C pulses, respectively, cause anomalous A, B, C, and D pulses and, b) pulses 1, 2, and 4 cause anomalous pulses 4, 2, and 1 strikes a familiar note.

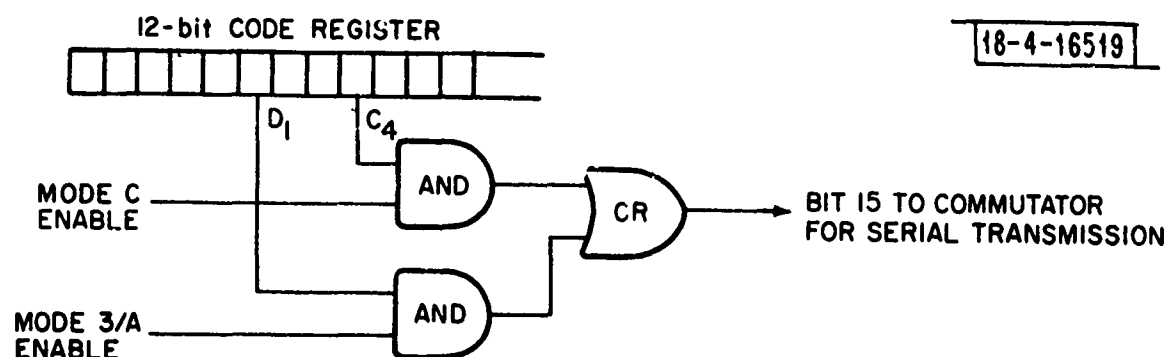
Fig. 37 ARTS III Reply Code Readout Circuitry

Given this fact, one can speculate with reasonable soundness on what is causing the anomalous codes in the Logan ARTS-III. The System Description manual [12] does not present detailed logic diagrams of the entire DAS, but does indicate in the DAS detailed block diagram (Fig. 3. 2-7) a functional unit (called the "Code Transformation Gates") which formats DAS reply words. That unit is hard-wired to read out the code bits in either of the above formats. Telephone conversations with Burroughs personnel reveal that circuitry of the sort shown in Fig. 37 (a simple "toggle") is employed (only the circuitry for bit #15 is shown for clarity):

The enable lines are driven by a set of flip-flops, which are set at the beginning of each sweep, and reset by the maximum range pulses. Any improper enabling signal on the wrong enable line would allow the C_4 bit (if present) to pass the and-gate, and appear in bit position 15 (where the D_1 pulse would be expected in a mode 3/A data word). Intermittent existence of such an enabling signal would cause intermittent presence of an anomalous pulse in the D_1 (or any other) position of a mode 3/A reply word whenever the C_4 pulse (or whatever pulse in the mode C line of the above table corresponded to that particular position) was present. This is precisely the behaviour that was displayed in the data.
